Experimental Study ND 98-05

**Sawing and Sealing Joints in Bituminous
Pavement to Control Cracking**

Second Evaluation

Project NH-7-085(028)126

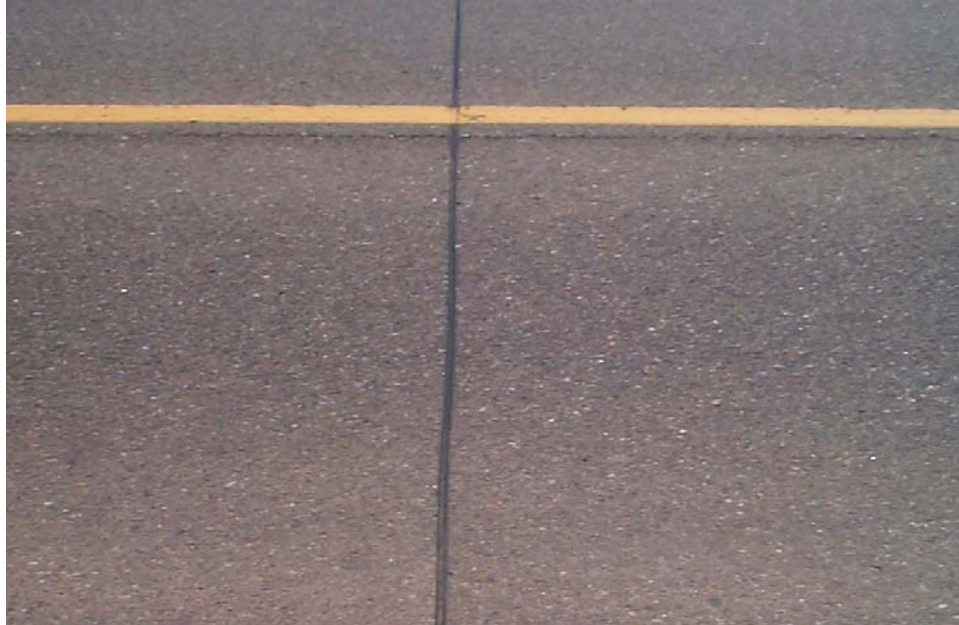
This section has 30' joint spacings and Type A reservoirs in the joints. This section has a smooth ride and the joints are not depressed. The sealant is intact in the joints and still in good condition. A typical sawed and sealed joint can be seen in Photo 1. There are no cracks in this section. The success of this section can be seen in Table 4.

Photo 1 – Sawed and sealed joint with no visible defects.

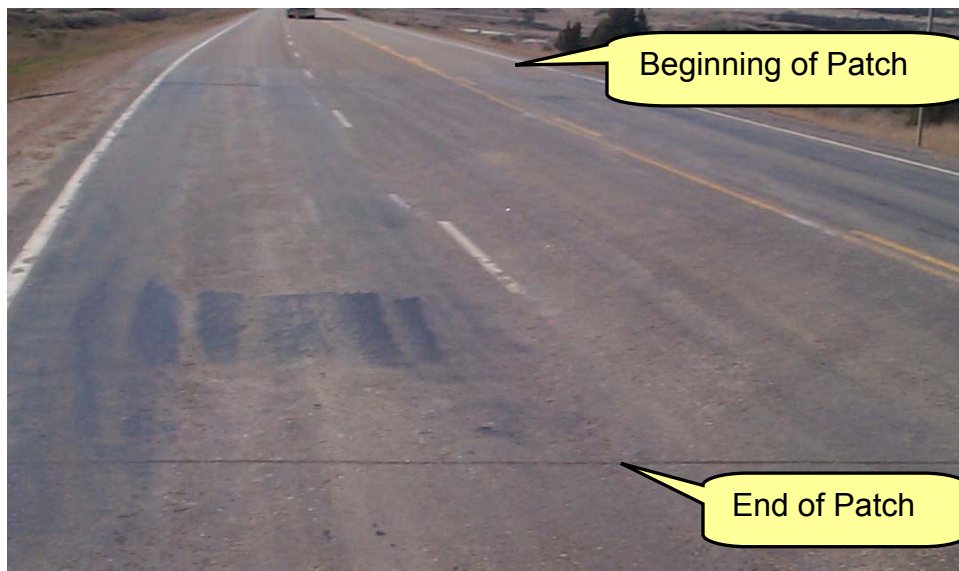
There are two patches on this section between the stations 6700+34 to 6753+14. These patches are approximately 50' to 80' in length and are in both lanes of the roadway. Each patch has a transverse crack in it. These cracks were omitted from the success calculation because the crack is formed from the reflection of the sawed and sealed joint beneath the patch. A patch can be seen in photo 2.

Photo 2- Patch that extends across both lanes.

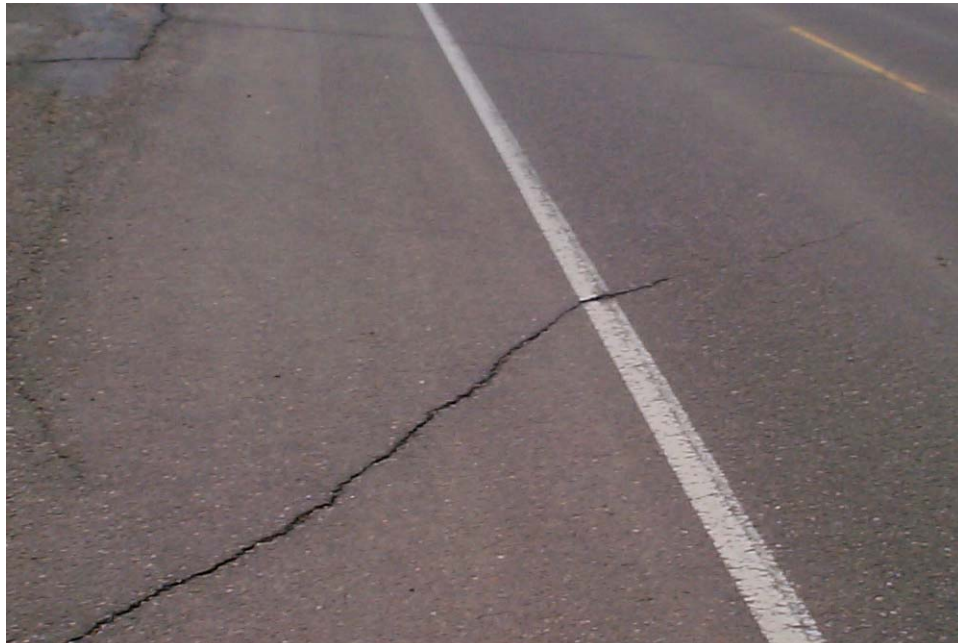
This section has 40' joint spacings and Type B reservoirs in the joints. The Type B reservoirs have 5/8" depth as compared to the 3/4" depth in Type A reservoirs. This section has a smooth ride and the joints are not depressed. The sealant is intact in the joints and still in good condition. There is very minimal transverse cracking in this section. There is one crack in this section. This crack may have been caused by the

Photo 4 – Crack next to an approach.

approach next to the roadway. The crack can be seen in Photo 4. The approaches or intersections can cause a crack that is angled across the roadway as seen in Figure 4. A possible solution to these cracks next to the approaches or intersections is to saw a transverse joint on the roadway where the intersection or approach meets the roadway. The success of this section can be seen in Table 10.

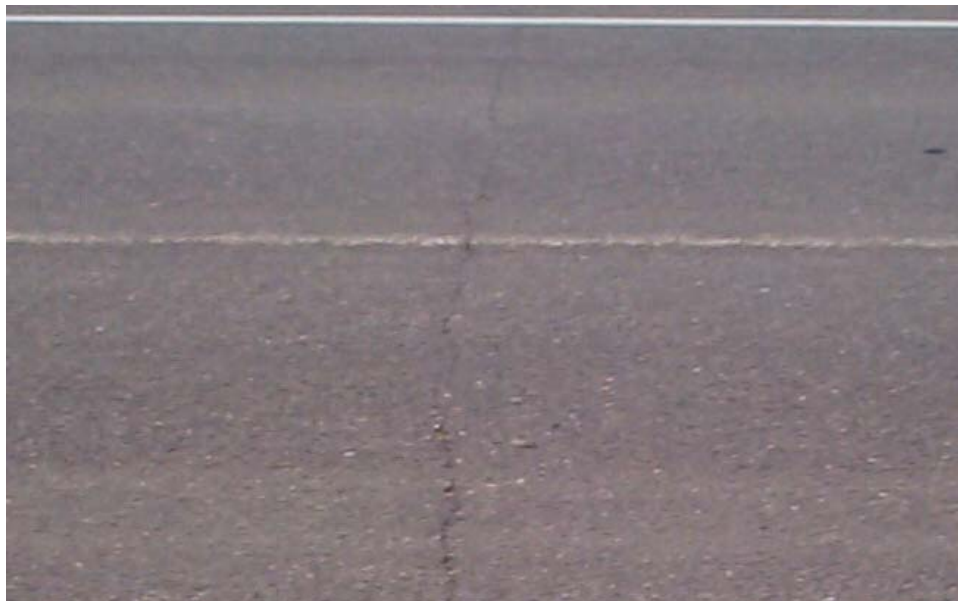
The control section limits of this research project are from RP 130.9813 to RP 140.0002. This is the entire roadway between the two sawed and sealed sections at the beginning and the end of the project. This section appears to be in good shape and the cracks were not depressed. We counted 30 cracks throughout the control section. There is no definite pattern to the transverse cracks except that there were cracks near approaches. Photo 6 depicts a random transverse crack in the control section.

Photo 6 – Transverse crack across roadway in control section.
